Enigma3m – installation finds two leaks in Tønsberg, Norway

Introduction

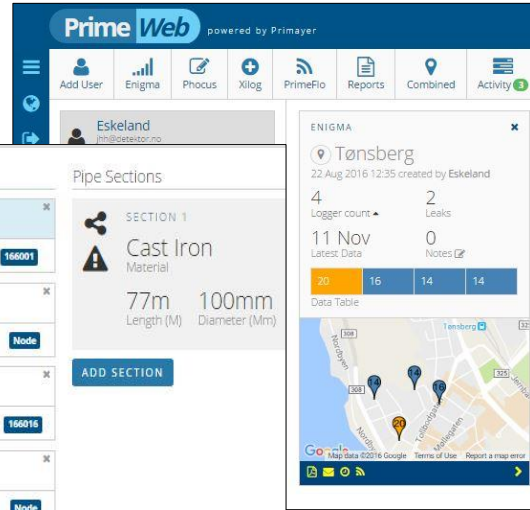
The devices communicate GPS location and sound files to the PrimeWeb online analysis tool. The operator can input the network

Network information input via PrimeWeb

diagram plus pipe details and change linear pipelines, from available data, if the distances from default Google Maps* prove incorrect.

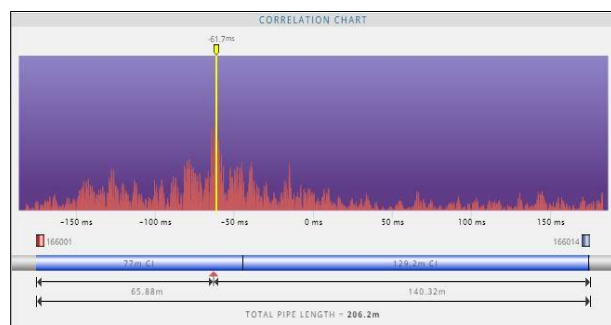
First leak position correlation between loggers 166001 and 166014

The correlation results show that there was a leak 44 metres from logger number 166016 and the second leak was 66 metres from logger number 166001. The leaks were confirmed by on-site listening on the ground. Shortly after the positions were identified the first leak position was excavated and the leak location accurately confirmed. The leak size was measured as 0.1 litres/sec leak. This equates to wastage of over 3100m³ per year.

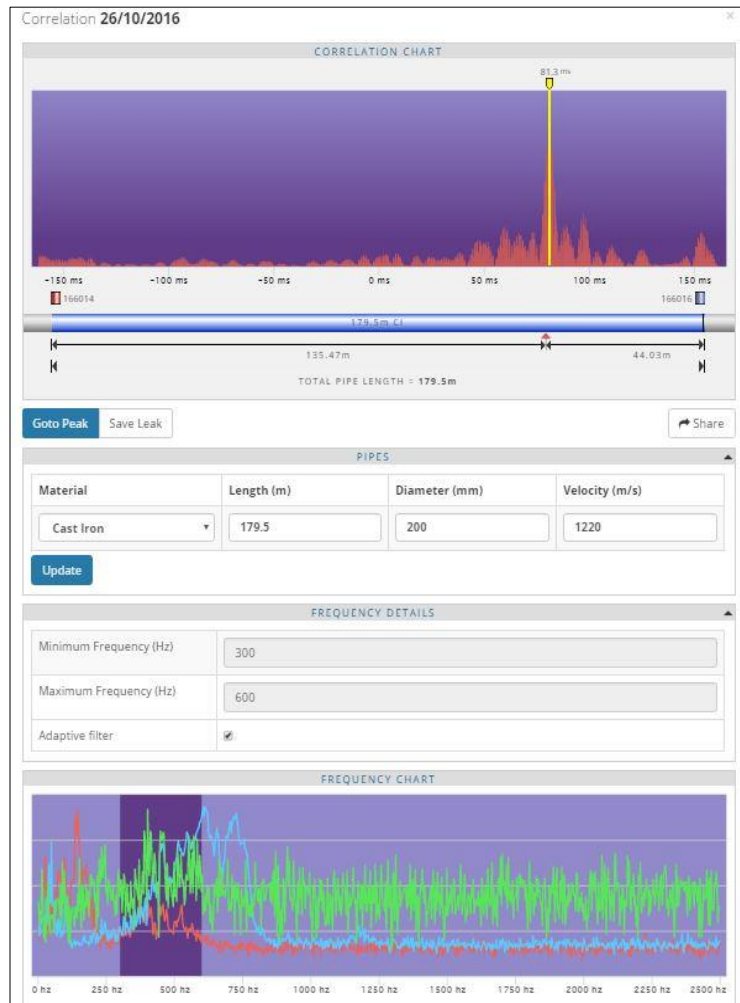
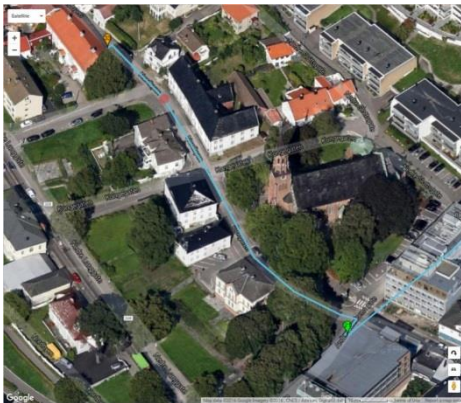
Second leak correlation and frequency spectrum display between loggers 166014 and 166016
