Xstream step testing via GPRS

With Portsmouth Water

Case Study XS-CS-UK-1.0

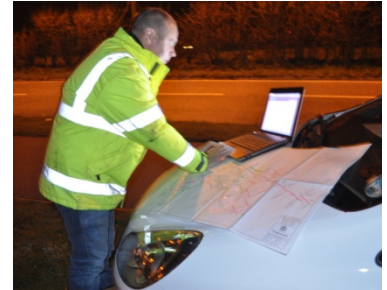
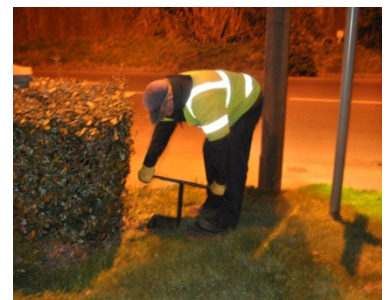
A DMA near Chichester was identified as an area with an unusually high night line and it was put forward to carry out a step test using the Xstream system. The DMA is predominately a residential zone and has been planned to be split into 6 shuts. The step test started at 01:00 with each shut being closed every 15minutes. The Xstream data transmitted to a laptop with a low GPRS signal. It managed to update the webpage every 10 seconds, as programmed into the Xstream. There were two significant drops in shut 2 and 3 which both respectively dropped by 2l/s. Twelve leaks in those shuts were found in the following week by Portsmouth Water leakage inspectors.
